The Biofilm Problem

The Untreated Procedural Water in Your Dental Unit Waterlines Should Not Be Used on Patients

STAGES OF BIOFILM GROWTH IN UNTREATED WATERLINES

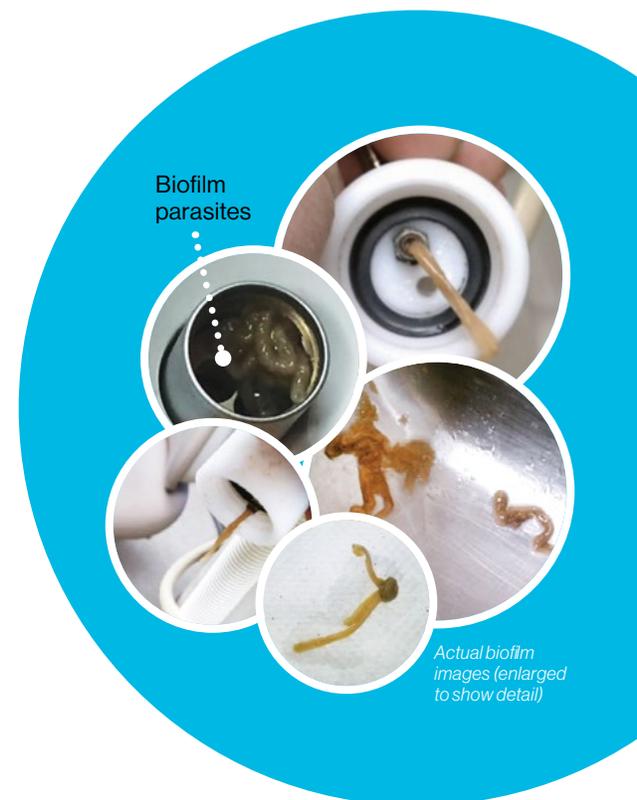
Uncontaminated Waterline

Biofilm Formation, Early Stage

Biofilm Maturation

Actual biofilm images (enlarged to show detail)
